POL PIER REPAIRS  
LAJES FIELD, AZORES

CONSTRUCTION INSPECTION VISIT NO. 2  
JULY 1980

CONTRACT NO. N-62477-79-C-0021  
MODIFICATION P-00001

OLKO ENGINEERING  
CONSULTANTS - DESIGNERS  
500 FIFTH AVENUE  
NEW YORK, NY 10036  
(212) 279-2822

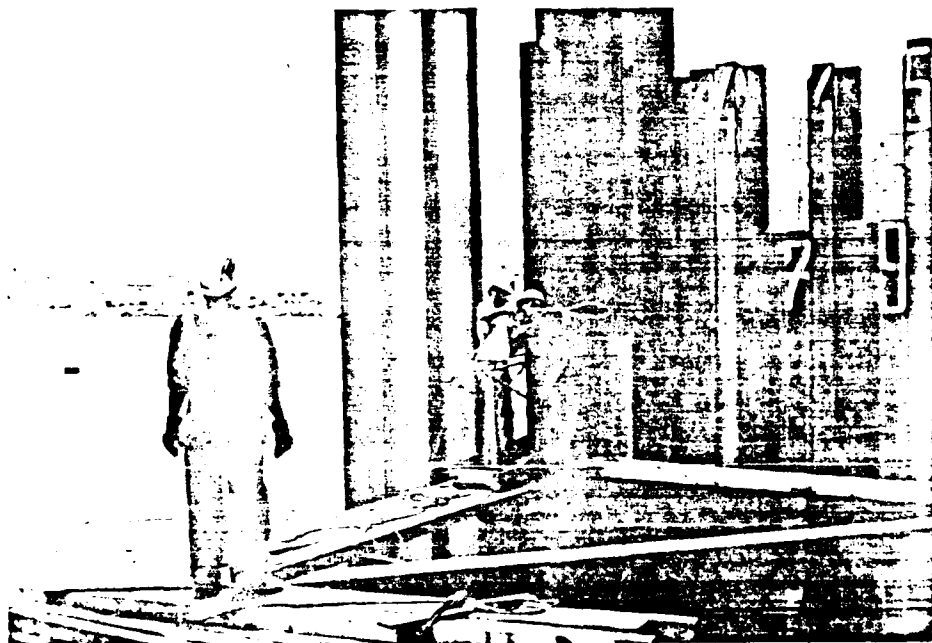
NEW NORTH DOLPHIN  
Threading Sheets at the North End of the West Wall.  
The Other Three Walls Have Been Partially Driven.
